MEMORANDUM

REFERENCE: Task No. 18013-3
Rock Creek Hills Study

DATE: June 28, 2018

1. INTRODUCTION

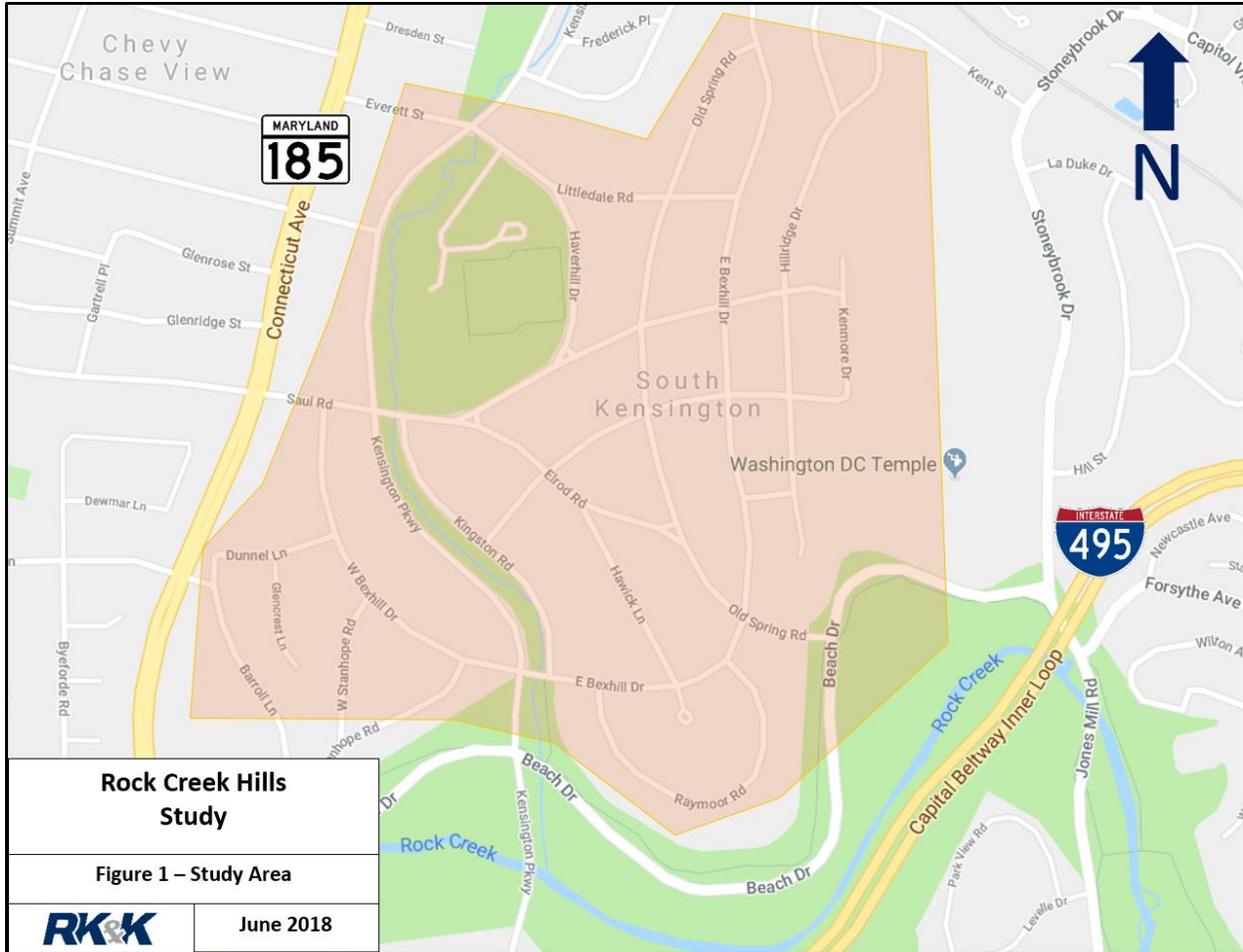
Figure 1: Rock Creek Hills Study Area

The study area consists of two primary residential roadways (Saul Road and Kensington Parkway) and nine secondary residential roadways (Littledale Road, Bexhill Drive, Old Spring Road, Kingston Road, Dunnel Lane, Barroll Lane, Franklin Street, Elrod Road, and Everett Street). **Figure 1** shows the study area map.

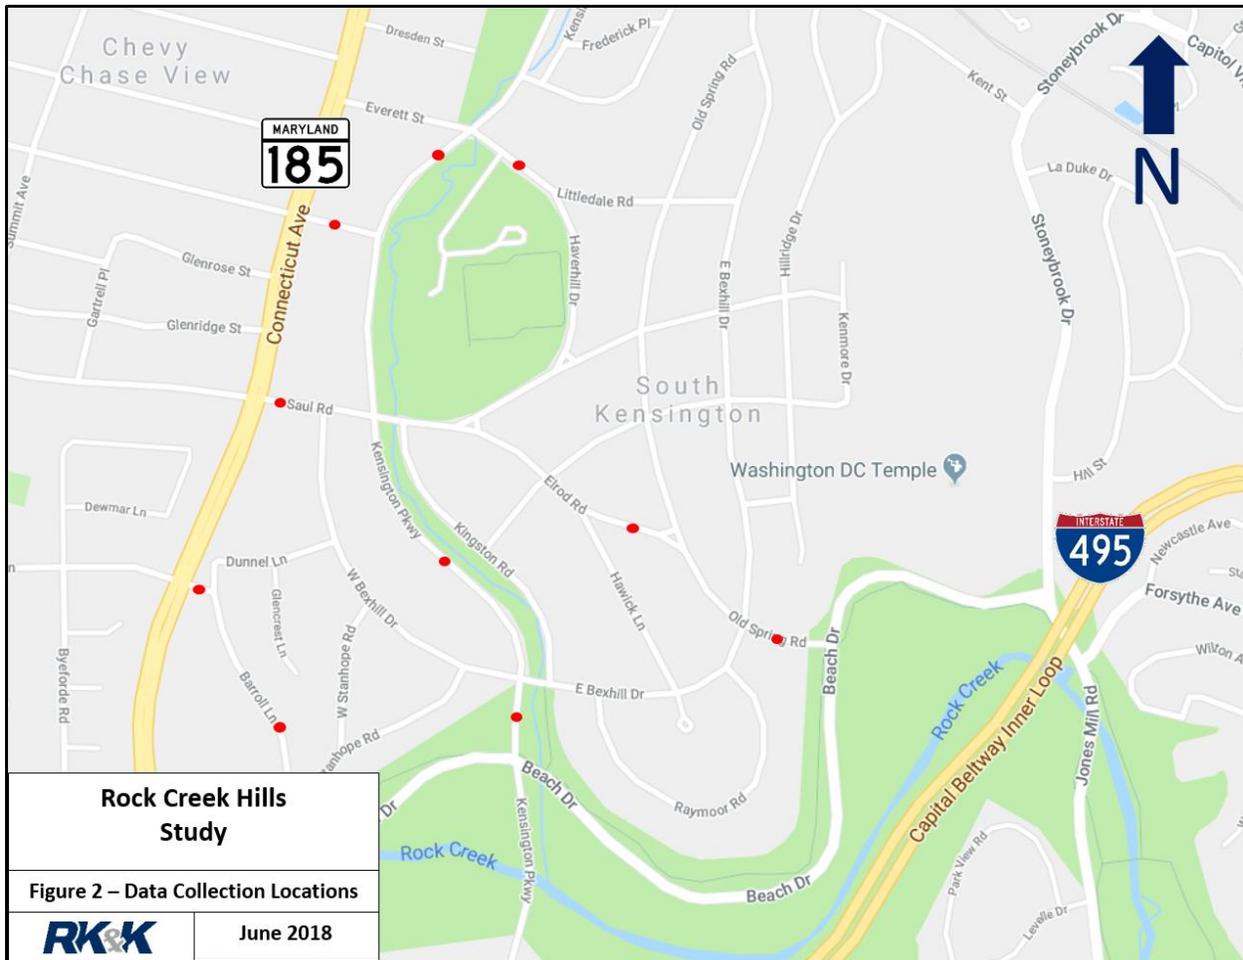
Figure 2: Traffic Count location

RK&K conducted a 24-hour tube count to collect volume and speed at thirteen locations on April 18, 2018 in the study area. Traffic count locations are presented in **Figure 2**. Traffic counts are provided in **Appendix A**.

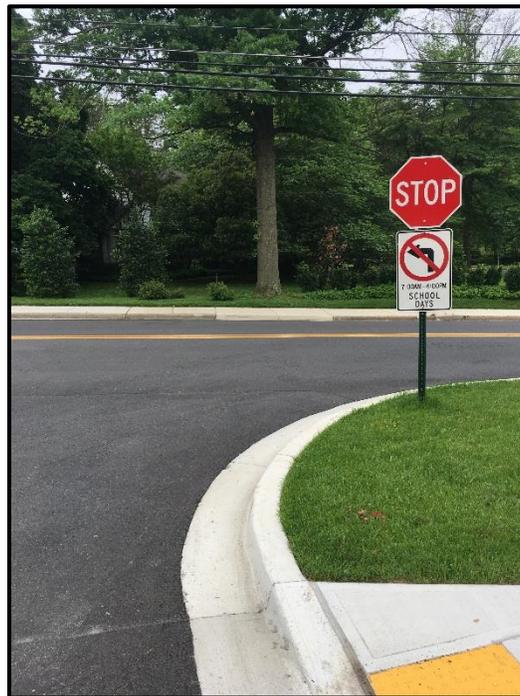
Figure 3. “NO LEFT TURN SIGN” at school exit

During the field observations, drivers were observed to either overlook or not follow some regulatory signs, such as stop signs, no-left turn signs and speed limit signs. Several instances of speeding were also observed on the roadway, especially on Kensington Parkway and Saul Drive-Elrod Road. Drivers were observed to not come to a full stop at the stop signs, instead they were observed to roll through the intersections on several occasions. This was observed mainly at the intersection of Saul Drive and Kensington Parkway, as well as at a few other intersections. There is a NO LEFT TURN sign at the exit of the school, on Saul Drive, as shown in **Figure 3**. A few vehicles were observed making a left from the school. School traffic during the AM drop-off and the PM pick-up didn't appear to have any adverse effect on the adjacent roadway (Saul Road).

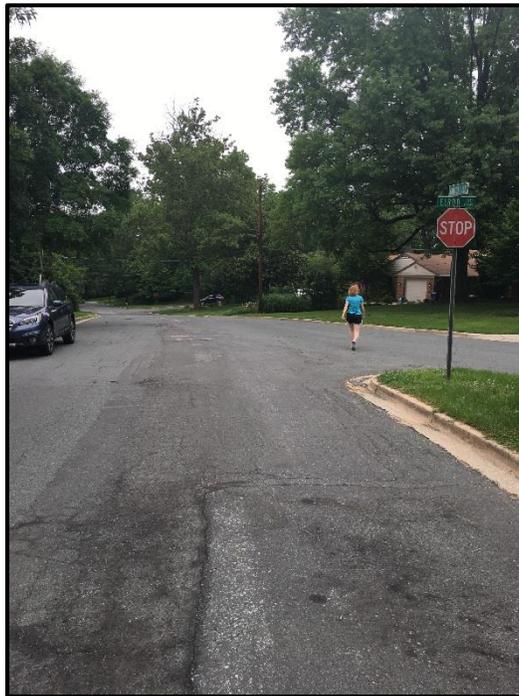
Figure 4. Pedestrian observed walking in the road

There are no sidewalks in the community other than on Kensington Parkway and Saul Road from Connecticut Avenue to the school access at 3705 Saul Road. Pedestrians were observed sharing the roadway with passenger vehicles, busses and bicycles, as seen in **Figure 4**. Lack of paved bus stops and sidewalks forces pedestrians, recreational and commuting, into sharing the roadways with vehicles. Most of the available sidewalks in the community have ADA compliant pedestrian ramps, as appropriate. At the intersection of Litledale Road and Kensington Parkway, pedestrian ramps on the east leg are not facing/aligning with each other and don't have a detectable warning surface (DWS) on them. At the intersection of Franklin Street and Kensington Parkway, there are no pedestrian facilities (sidewalk or ramp) leading to the pedestrian trail/bridge north of the intersection, except the crosswalk with fading markings on the north leg.

A Sidewalk Connectivity and Feasibility Assessment was conducted by the Montgomery County Department of Transportation (MCDOT) Division of Transportation Engineering in the area near Silver Creek Middle School. The project team is awaiting the results of this assessment and, once received, can determine if any proposed sidewalk would allow for additional opportunities for safety improvements.

MCDOT conducted a sidewalk connectivity and feasibility assessment. The findings of the assessment, once received, can be reviewed to determine if there any additional opportunities for safety improvements. Appropriate improvements to the sidewalk network will benefit the pedestrian accessibility in the area.

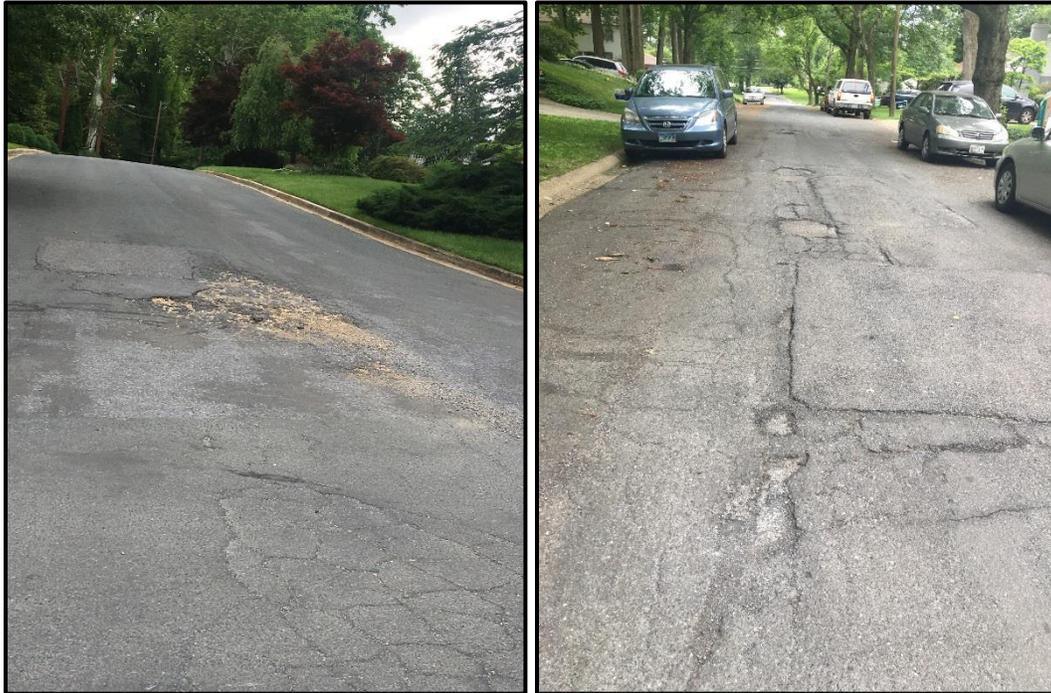
Figure 5. Examples of damaged pavement in the community

The roadway pavement in the neighborhood is mostly in fair to poor condition. There are asphalt cracking and potholes at most locations in the community. **Figure 5** shows examples of asphalt cracking on the roadway. Also, there are pavement edge drop-offs on some of the roadways, as shown in **Figure 6**.

Signs, pavement markings, and pavement improvements are faded/worn down in various locations throughout the community. ***It is recommended to replace faded/damage signs, refresh faded/worn pavement markings, install stop bars at existing stop sign locations (to promote increased compliance at stop signs), clear/trim any vegetation that impairs sign visibility and sight distance and repair damaged pavement.***

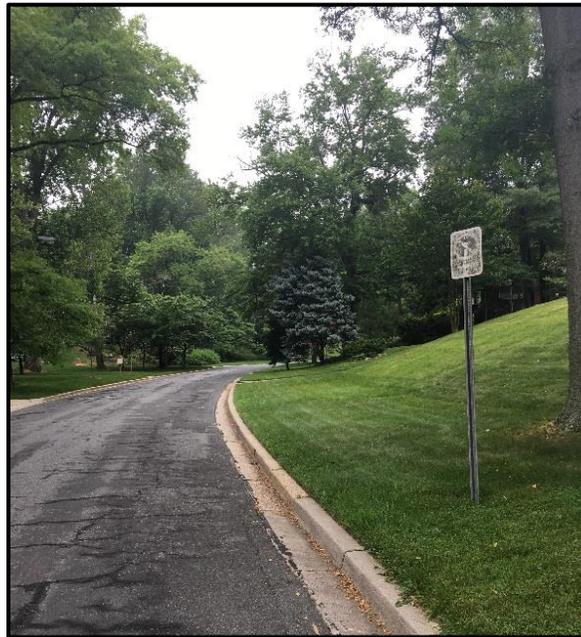
Figure 7. Faded “NO PARKING” sign

The ‘NO PARKING’ sign along Old Spring Road is fading, as shown in **Figure 7** and needs to be replaced. **Figure 8** shows a speed hump sign with advisory speed plaque blocked by vegetation along Kensington Parkway.

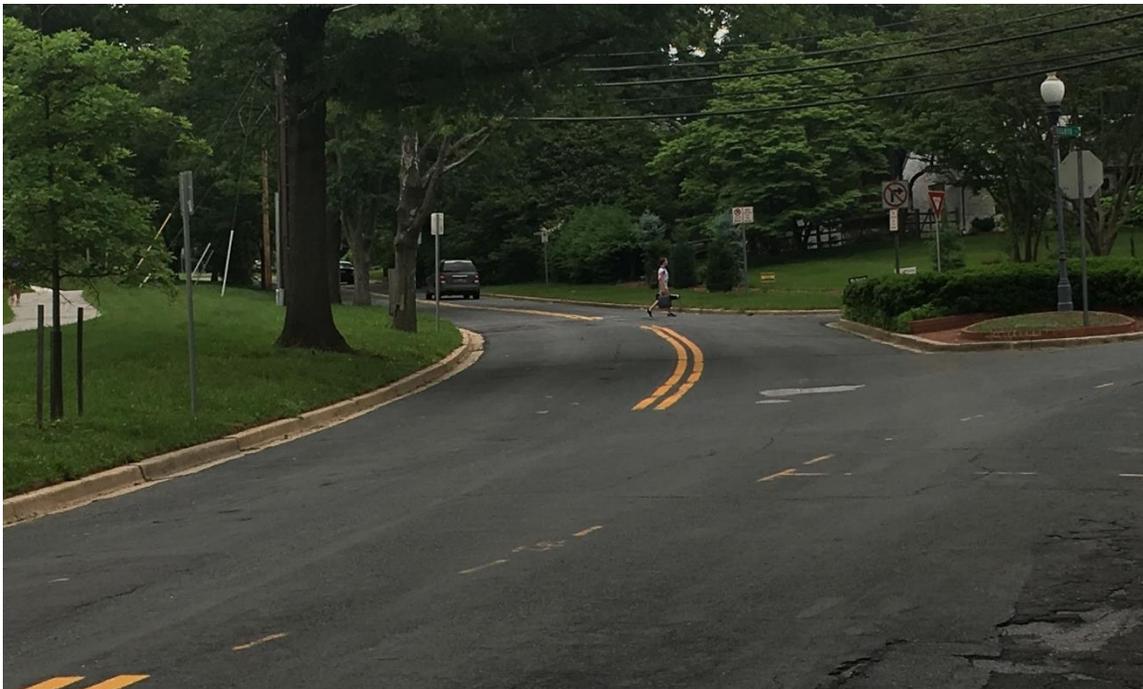
Figure 9. Children crossing with no crosswalk from the school.

- Parking on both sides of Elrod Road reduces it to one travel lane.
- Based on the night time observations conducted, the street lighting in the community appears to be adequate.
- Stop signs, measuring 24"x24", are located at the intersections of Calvend Lane and Elrod Road, and Hawick Lane.
- There is a lack of defined pedestrian accommodations (bus shelter, concrete pad) at the existing bus stops in the community.
- Children were observed crossing from the school in the middle of the block along Saul Road, as shown in **Figure 9**.
- There appear to be substandard guardrails in the community.

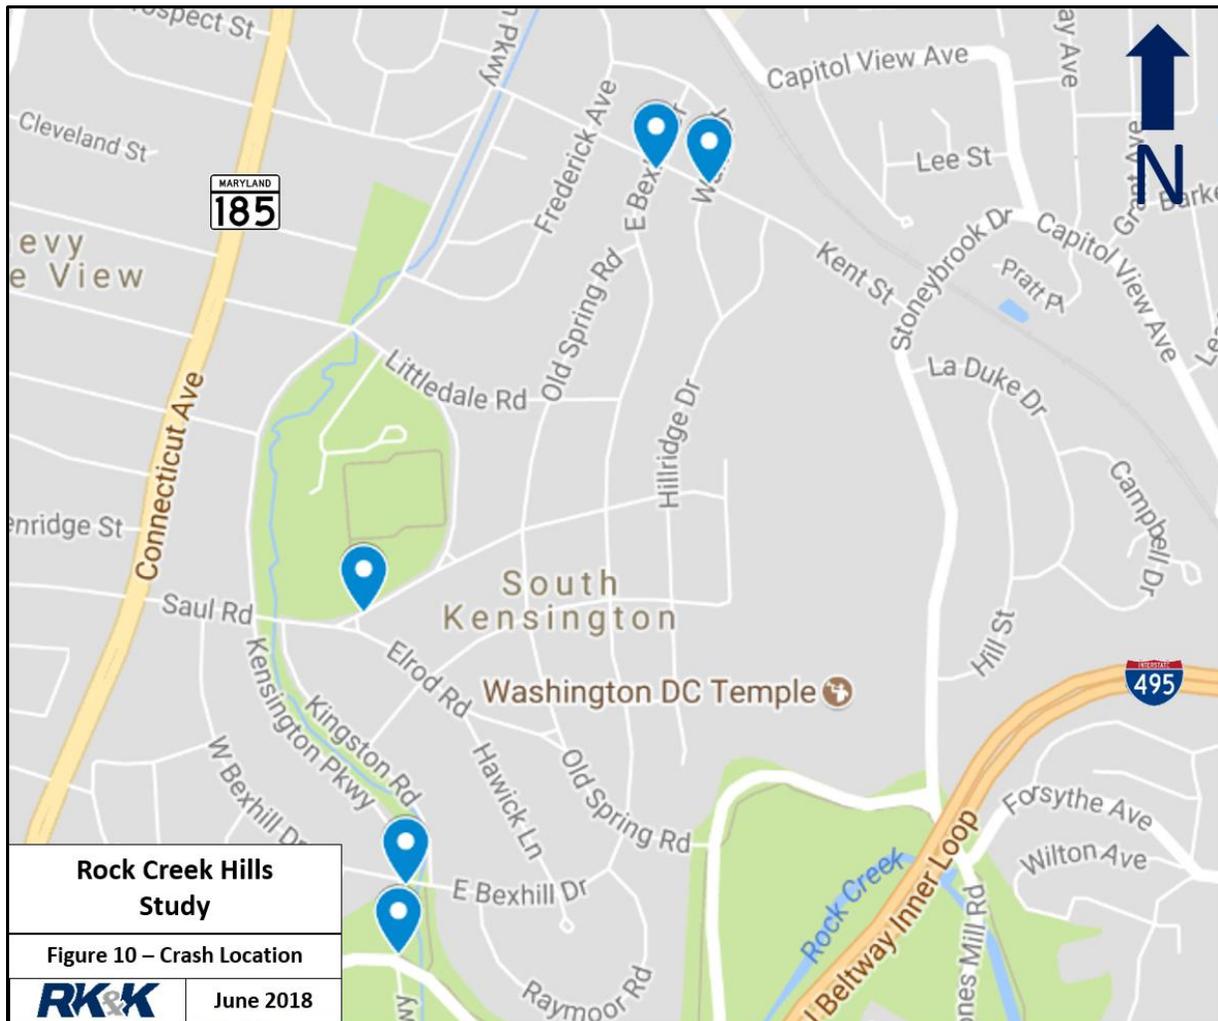
Figure 10: Crash Locations on Rock Creek Hills Community

- There was a total of five (5) crashes on the roadways in the community over the last three years, as presented in **Figure 10**. Two (2) crashes occurred on Kensington Parkway, one (1) crash occurred on Saul Road, one (1) occurred on Bexhill Drive, and one (1) occurred on Kent Street.
- The crashes included two (2) angle crashes, one (1) fixed object crash, one (1) rear end crash and one (1) crash involving a parked vehicle.
- The crashes resulted in four (4) property damage only (PDO) crashes and one (1) injury crash.
- Three (60%) of the crashes occurred during day time, and four (4) of the five (5) crashes occurred under dry conditions, with clear weather.
- The crash at Kensington Parkway and Beach Drive involved a bicycle.

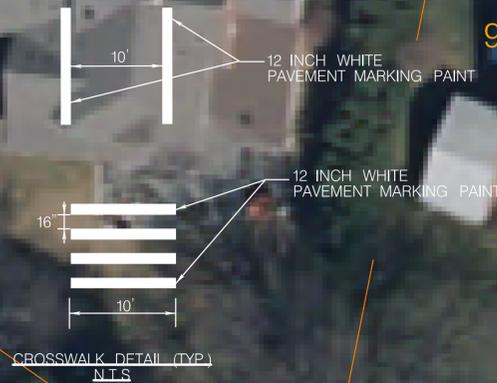
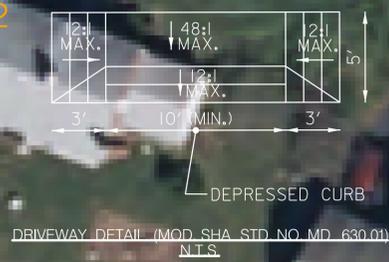
ROCK CREEK HILLS STUDY
ELROD ROAD AND SAUL ROAD
 SCALE: 1" = 20' SHEET 1 OF 2

The two options considered for this intersection are a T-intersection conversion and a roundabout. The first option involves converting the intersection into a T-intersection. The southwest and southeast curbs would be bumped out toward the triangular channelizing island to reduce right-turn radius for the intersection. The channelizing island would be removed and the existing plaque located there, would be relocated to the new side of the roadway. Saul Road would be the mainline and Elrod Road would be considered the side street. The T-intersection will be stop controlled, with the stop sign on Elrod Road. A crosswalk would also be installed across Elrod Road.

The Rock Creek Hills Community requested intersection modifications at two locations in the community. The intersections are Elrod Road and Saul Road, and Elrod Road and Old Spring Road. The roadways are downhill roads and two-way stop controlled. ***It is recommended that intersections be modified to a T-intersection at both intersections, or conversion to a roundabout at the intersection of Saul Road and Elrod Road.*** Island refuges and/or small medians will be installed on the approaches of the roadway at the modified intersection.

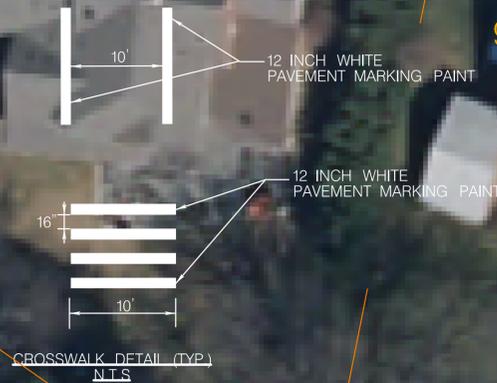
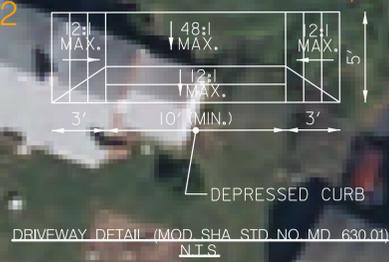
ROCK CREEK HILLS STUDY
ELROD ROAD AND SAUL ROAD
SCALE: 1" = 20' SHEET 2 OF 2

The second option would install a roundabout in place of the existing triangular island, with splitter islands on each approach. The central island would have a mountable curb. The southwest and southeast curbs would be bumped out toward the triangular channelizing island. The triangular channelizing island would be removed.

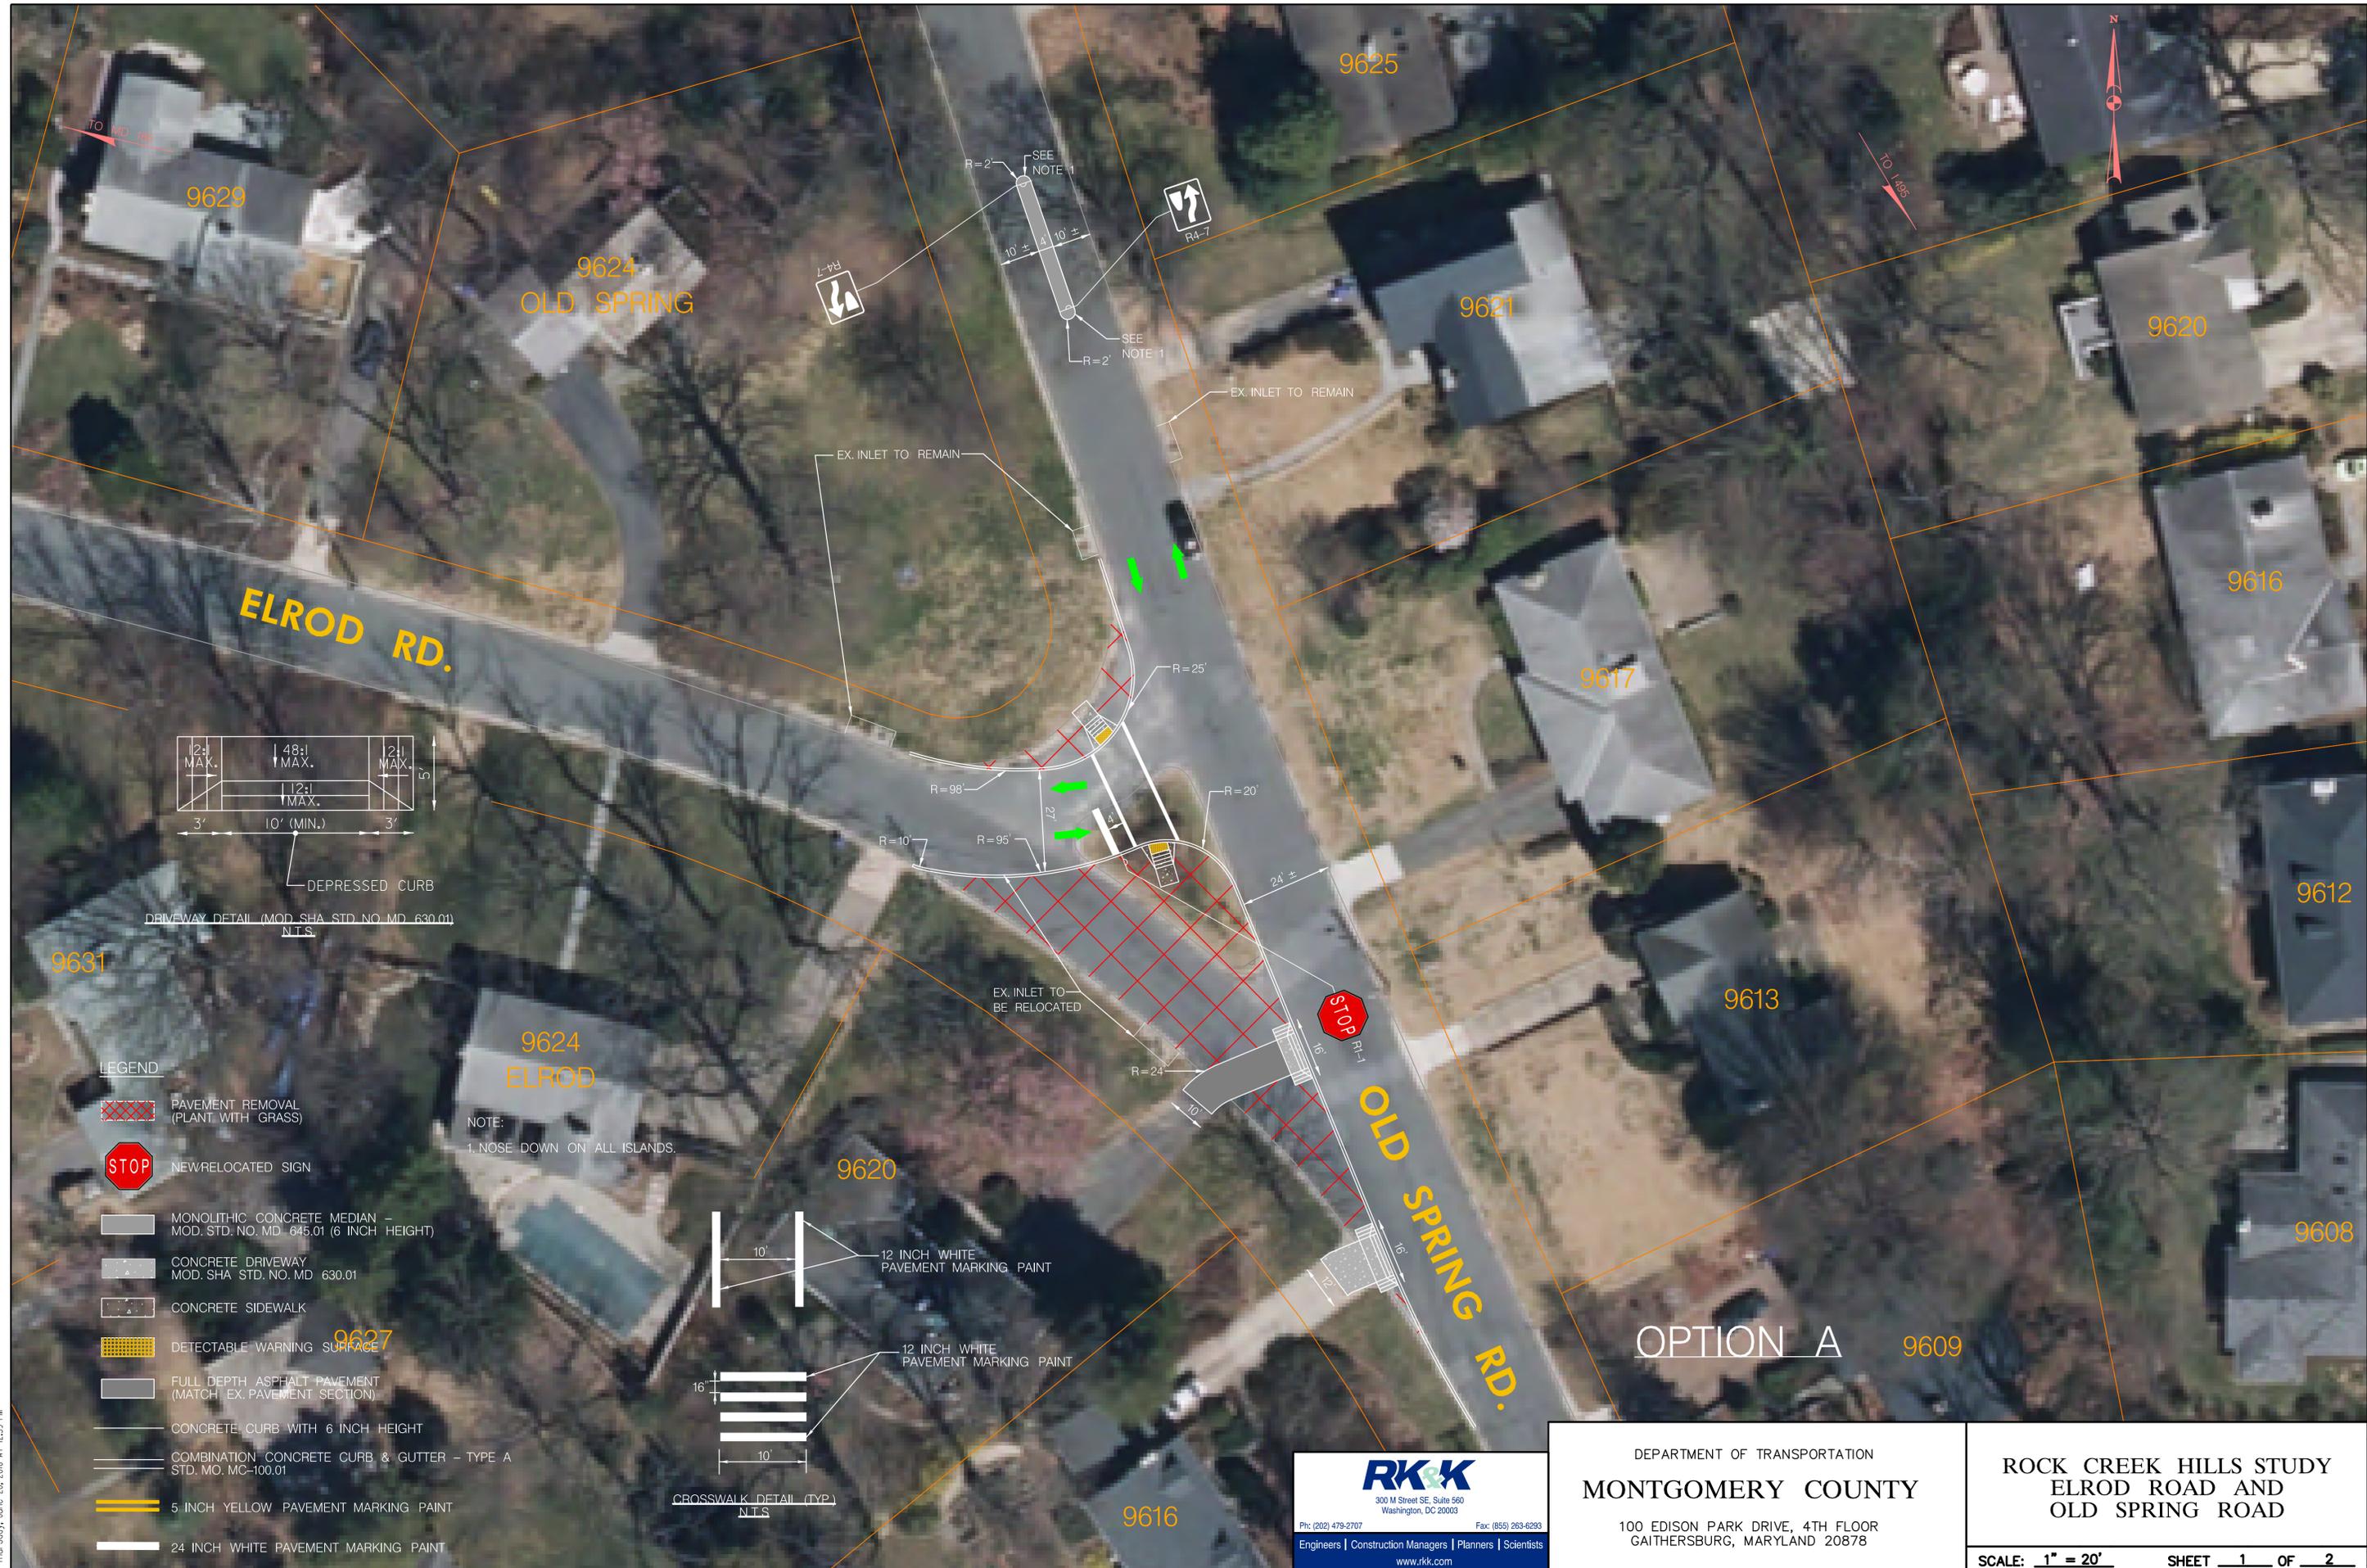
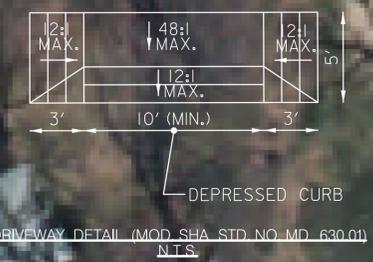
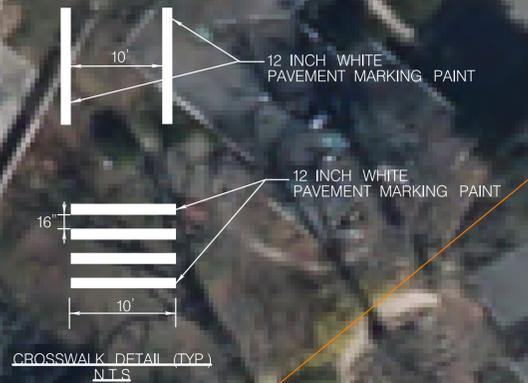
ROCK CREEK HILLS STUDY
ELROD ROAD AND
OLD SPRING ROAD
SCALE: 1" = 20' SHEET 1 OF 2

The options include two approaches to converting the triangular channelizing intersections into T-intersections. In Option A, the merging right turn movement from Elrod Road onto Old Spring Road would be closed off by bumping the southwest corner curb. The new intersection configuration would be a standard right angle right turn movement from Elrod Road onto Old Spring Road. The northwest curb would be bumped to reduce the right turning radius from Old Spring Road southbound to Elrod Road. The triangular island would be removed. Old Spring Road would be the mainline and Elrod Road would be considered the side street. The T-intersection would be stop controlled, with the stop sign on Elrod Road. A crosswalk would also be installed across Elrod Road.

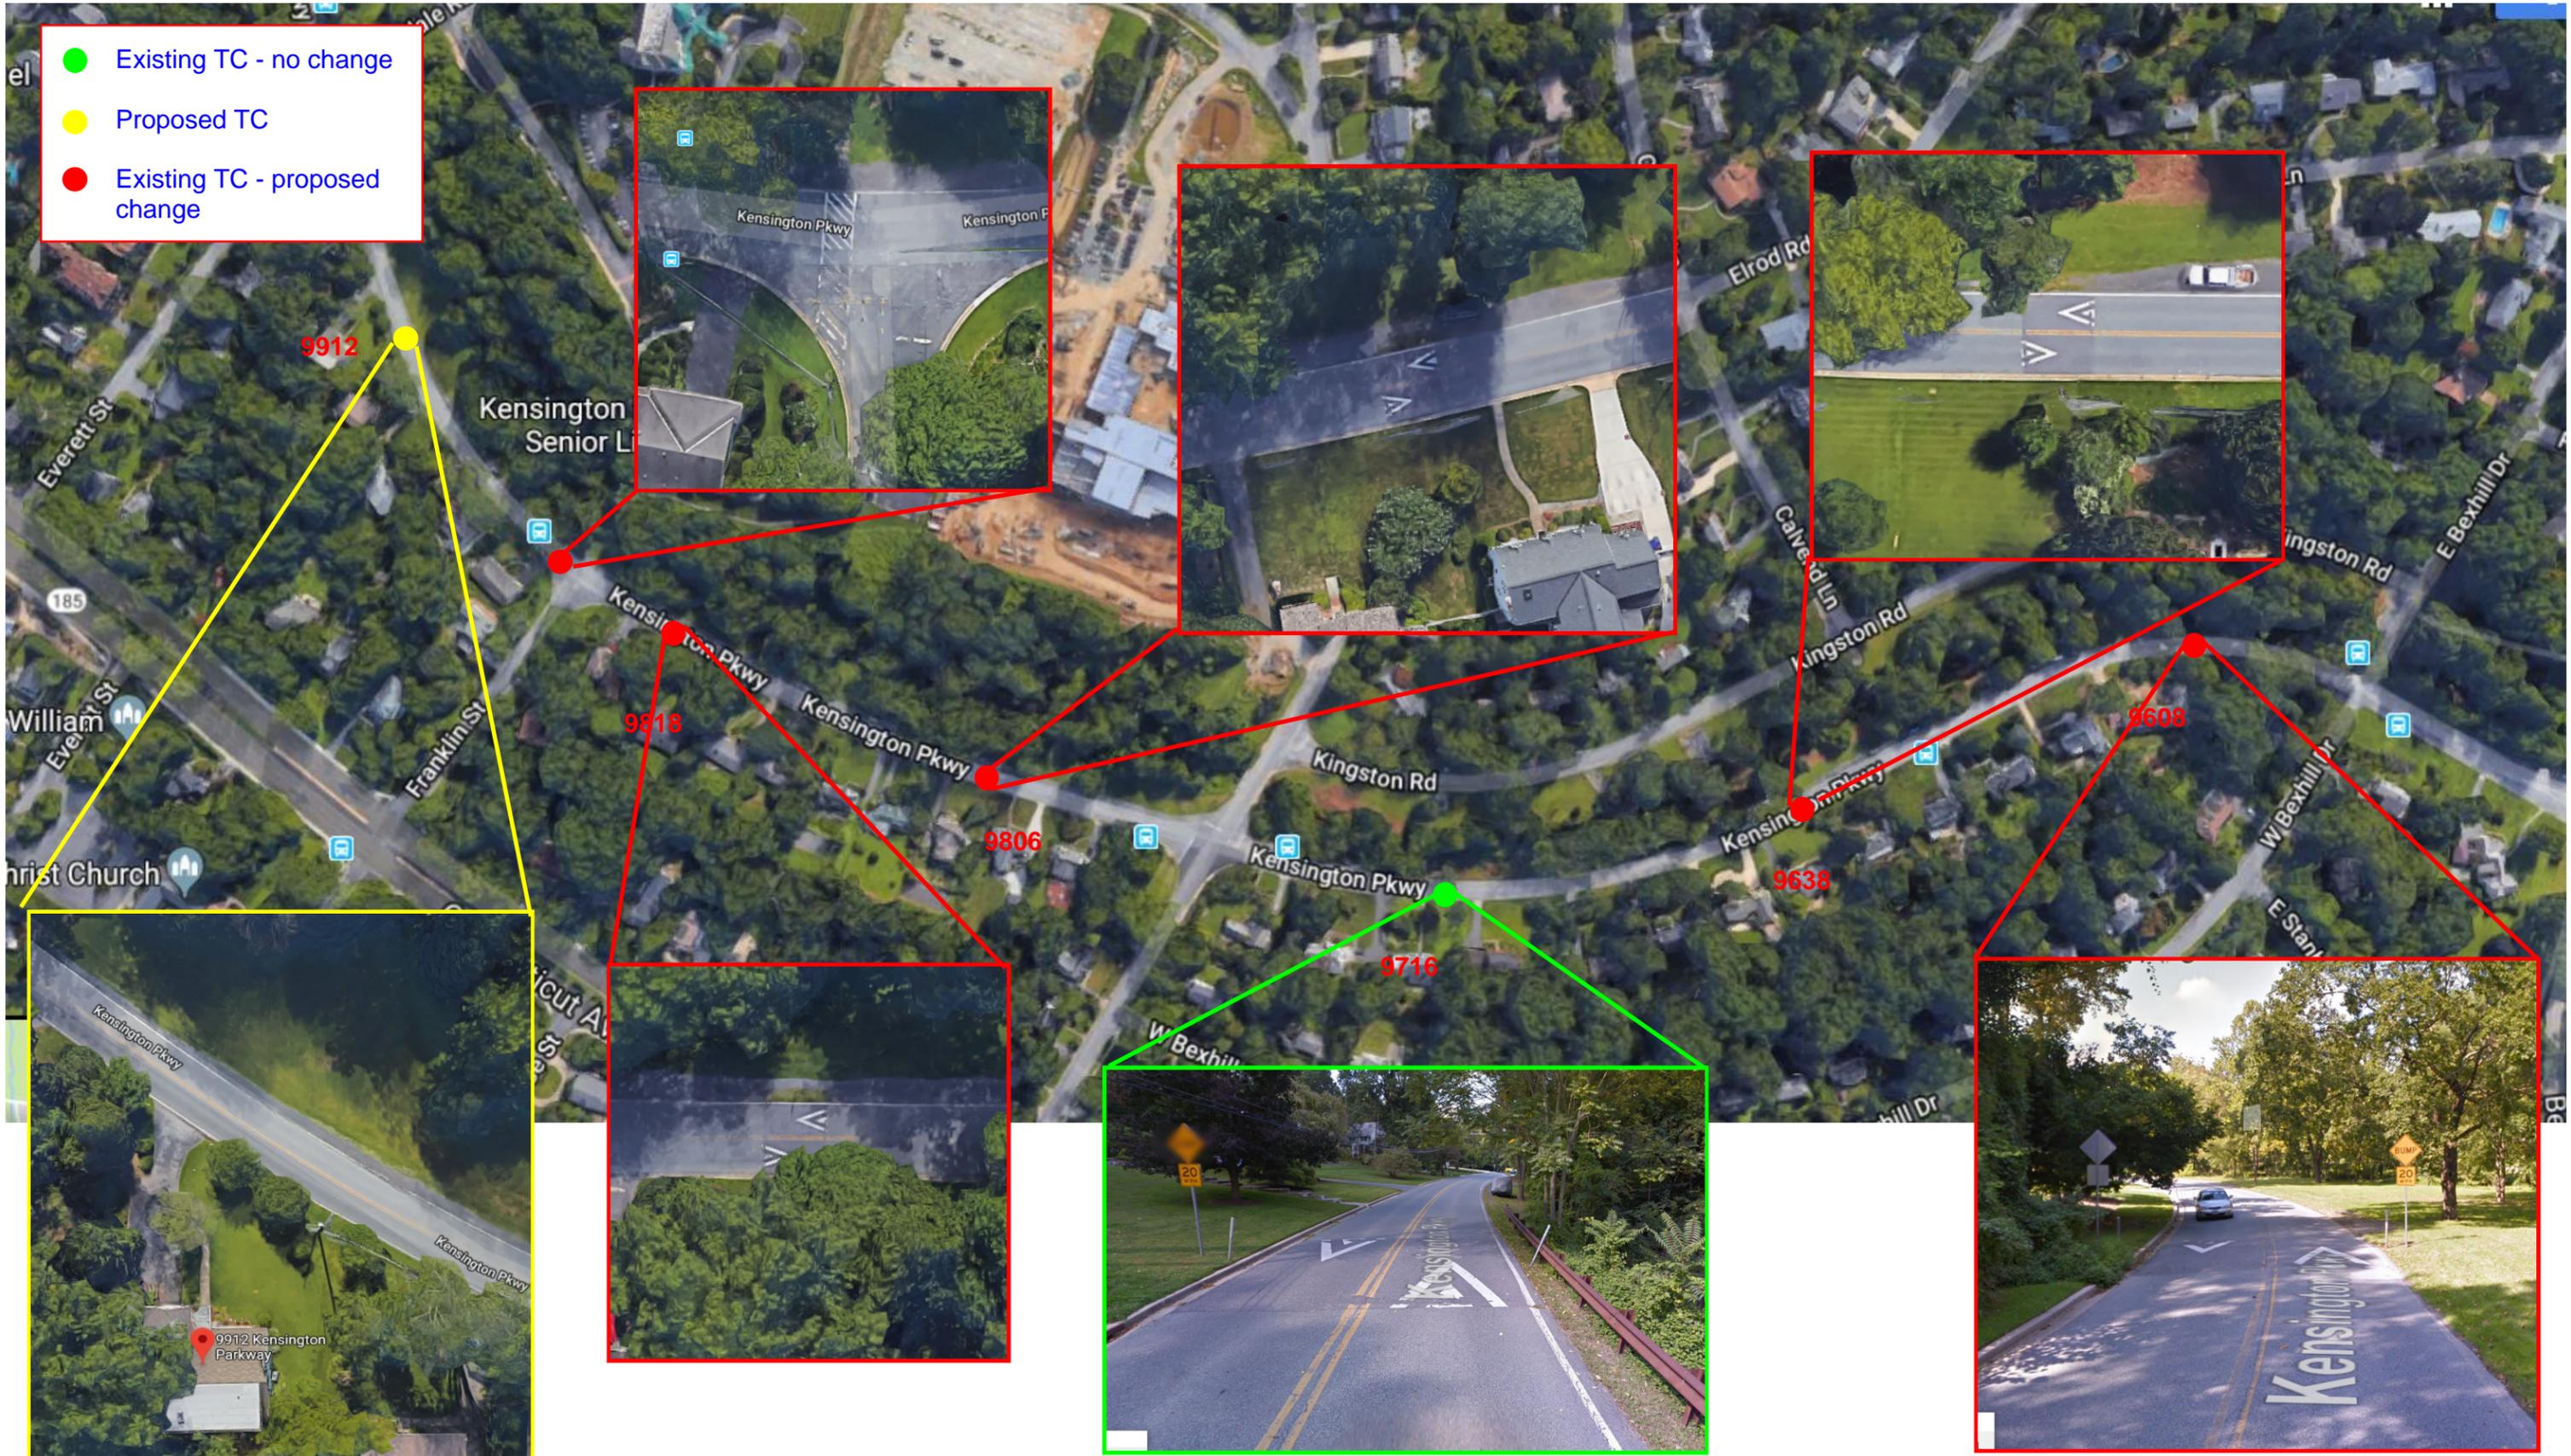
Kensington Parkway Existing Traffic Calming

As indicated previously in the report, speed data was collected throughout the neighborhood. Of significance were the 85th percentile speeds along Kensington Parkway, which exceeded the posted speed limit by 4–9 MPH in three collection locations. There are five existing speed humps along Kensington Parkway, within the study area. However, these speed humps alone do not appear to provide the level of desired traffic calming. As mentioned in the observations section, drivers did not appear to slow down or brake while approaching and/or navigating these speed humps. This partly may be due to the lower profile of the humps.

Based on the field observations and measurements, the speed humps, observed to be in poor condition, were measured at a height of 4 inches and a length of 22 inches. Kensington Parkway is considered a transit route, requiring a lower profile hump that would be less disruptive to both transit and emergency vehicles. Therefore, these current speed humps do not meet the roadway speed hump criteria. Other traffic calming measures are recommended to supplement the existing speed humps along Kensington Parkway. The proposed calming measures include bump-outs before and after the speed humps, on the side of the roadway opposite the homes, with a lateral shift and a temporary lane reduction to 10', at four of the five existing speed humps. The existing speed hump that won't be modified is located south of Saul Road on Kensington Parkway. The modification to this speed hump is hindered by the existing guardrail located adjacent to the speed hump. In addition to the four existing locations, adding a bump-out with lateral shift closer to Everett Street/Littledale Road is also recommended. This will alert drivers much sooner that this section of roadway is intended for lower speeds. Lastly, it is recommended to improve the existing uncontrolled crossing at Franklin Street by tightening the curb radius in the northwest corner, providing slight bump-outs on the east side, on either side of the crosswalk, and refreshing the crosswalk pavement and signing. A figure illustrating these recommendations is included in **Appendix D**.
